<p>Index Card #1</p>	<p>ETZ HAYIM</p>

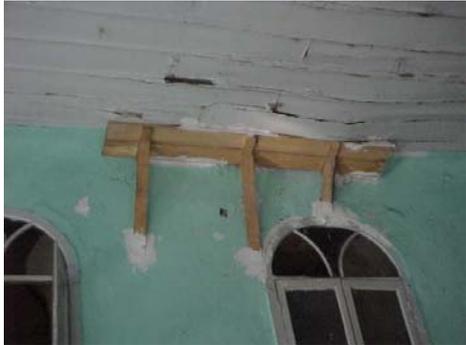
<p>General View from Inside</p>
<p>Physical Conditions</p>	<p>The building is in bad condition. The roof is badly damaged, and the structure is in danger of collapse. The “Ezrat Nashim” is not in good condition; and the use of wooden panels divides it from the larger space.</p>

<p>The Roof Problem</p>

From the southern Wall	No											
<p>Conclusions</p>	<ul style="list-style-type: none"> • This synagogue is the second problematic synagogue in Izmir, after the Hevra • If the roof of the synagogue is not repaired as soon as possible, this synagogue will be in the same condition as the Hevra synagogue. <p>As a recommendation, the roof of this synagogue should be repaired immediately, before it collapses.</p>

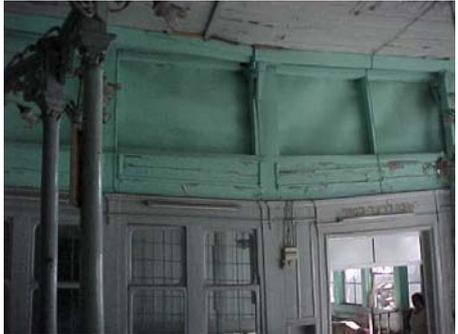
<p>Section Showing the Deformation</p>

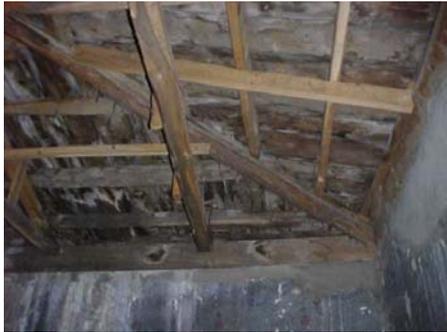
<p>The Situation of the Roof</p>	
<p>Technology Materials</p>	<p>The building is of masonry. The roof, windows, ceiling, and pillars are made of wood. The floors are the original marble.</p>	
<p>Unique Elements</p>	<ol style="list-style-type: none"> 1. Four pillars 2. Wooden ornaments on the ceiling 3. Synagogue does not have any entrance space.
