Index Card #7	BEIT HILLEL

<p>General Description</p>	<p>The synagogue was founded by Palaggi Family in 1840. It was used by Rav Avraham Palaggi. The building had been used as a synagogue and a “Beit Midrash.” The synagogue has not been used since 1960’s.</p> <p>One step leads to the iron gate of the synagogue. Then there are four more stairs and then the space is divided into two parts. The main space is on the left side. In the bigger space there are eight stairs leading to the gallery probably to the women’s section.</p> <p>The building can not be perceived as a synagogue building from the outside. It looks like a typical Greek house.</p> <p>There are windows on the northern wall opening to the street.</p>	
<p>General Pictures</p>

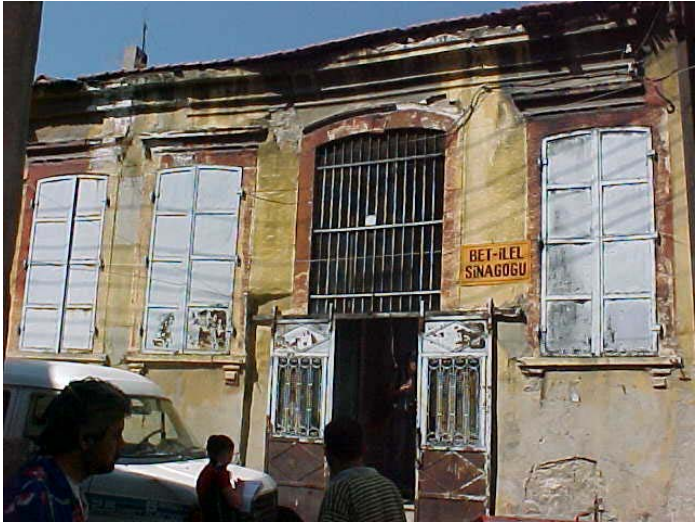
<p>The Entrance Façade of the Synagogue</p>		
Presence	The synagogue stands above the street, and its north façade can be seen easily from the outside.

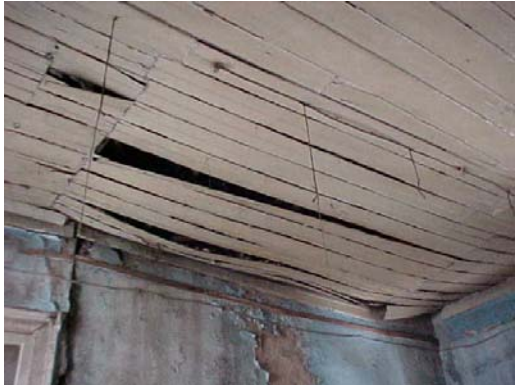
<p>Physical Conditions</p>	<p>The building is in bad condition. The roof is badly damaged, and some parts of the floor are missing. The timber ceiling is falling down.</p>

<p>Picture Showing the Condition of the Roof.</p>

<p>Ceramic Floor of the Interior Space</p>				
<p>Technology Materials</p>	<p>The building is of masonry. The roof is of wood. The windows, ceiling, women's section, and stairs are made of wood. The floor paving is not original.</p>				
<p>Unique Elements</p>	<p>1. The synagogue is part of a house</p>				
<p>Typology of the Plan</p>	<p>Bimah</p> <p>No remains</p>	<p>Pillars</p> <p>No remains</p>	<p>Ceiling</p> <p>No remains</p>	<p>Main Space Entrance</p> <p>From the eastern Wall</p>	<p>Courtyard</p> <p>No</p>
<p>Conclusions</p>	<ul style="list-style-type: none"> • The building has serious structural damages. • The roof, the walls and the floor of the building are in a very bad condition. <p>The synagogue was founded by the Palaggi family and is therefore very important. The roof, the walls and floor need immediate repair.</p>

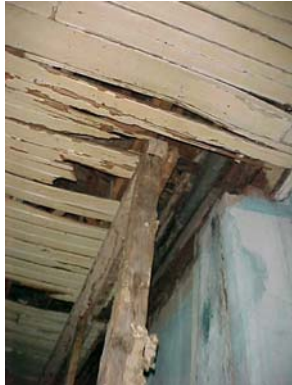
<p>Picture Showing the Condition of the Roof.</p>
