## Description of Plots According to Parcellation

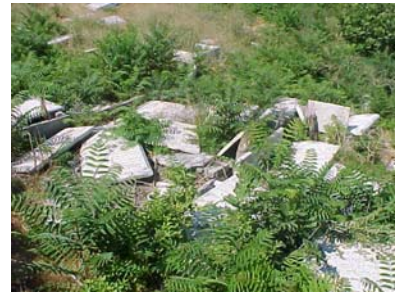
**A.1. – 1885-90** - The plot is located next to the western fence. Many graves are without tombstones, and many tombstones are broken. Shrubbery covers 50 % of the area. Along the fence there is a lot of litter. It is difficult to access the graves, for there are no paths.

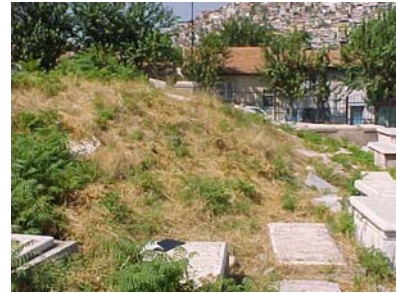
**A.2. – 1885-90** - The plot is located on a rise, next to the southern fence. It is hard to find complete graves. About 70 % of the area is covered with shrubbery. Along the fence there are stacks of tombstones piled one on top of the other. Many of the graves are covered with earth and litter.

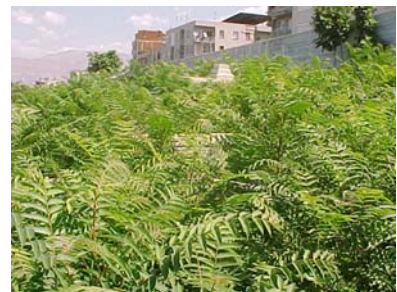
**B.1. – 1890-1900** - A badly affected plot. About 70 % of the plot is covered with shrubbery, damaging the graves. Many of the tombstones are covered by it or are broken. Some tombstone boxes are open. It is difficult to get to and identify the graves.

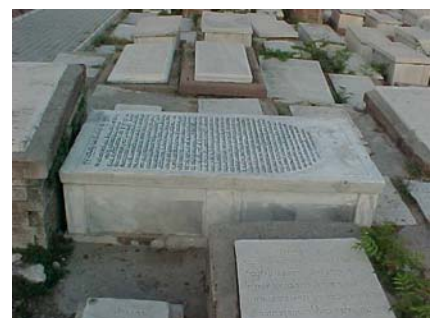
**B.4. – Rabbi Haim Palaggi's grave.** One of the graves that were brought over from the old cemetery and put in between the existing graves. This is the reason why the grave is at right angles to all the rest.

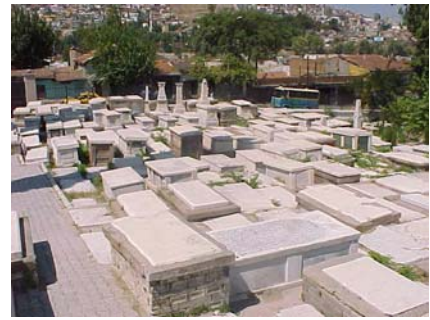
**B.5. – 1890-1900** - Along the path there are tombstones laid in no apparent order. In the southern side the years are clearer. The tombstones are crowded, though there is a clear pattern and the graves are easily accessed. Old tombstones brought in here are located in the remaining areas among the grave lines. Most of the graves are in good condition, though some are broken.

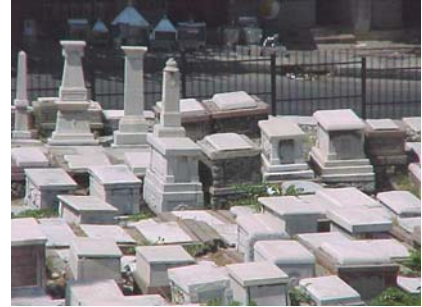
**B.7. – 1890-1906** - The plot is located between the road and the narrow path. Graves date back to many different years – some of the graves have been transferred, some are original (5670 and onwards). Two of the graves are the most ancient in the cemetery. The plot is easily accessible and in good condition. Some graves are tilted.

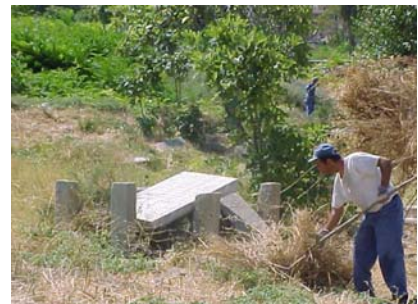
**C.2. – 1900 – 1920** - The plot is next to the Mikveh, covered in greenery (some of which is an orchard). There are a few graves that were moved out to the sides of the path. The graves are from different periods.

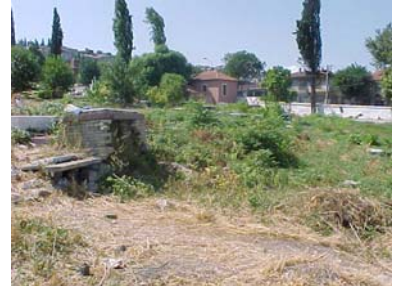
**D.2. – 1930-1933** - The plot is situated on a land terrace, and the graves are difficult to access, as some of them are covered with thorny wild berries and trees. Some graves are new and in good condition, but most are ruined.

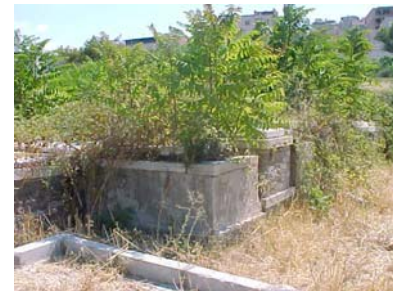
**D.4. – 1920-1930** - The plot is relatively new, mostly covered with thorny wild berries. The graves are difficult to reach. The tombstones are in poor condition – most are broken, covered or scattered.

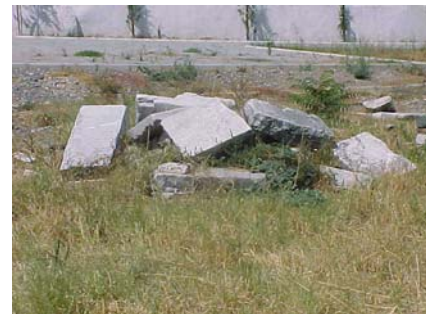
**D.8. – 1920-1926** - A later plot, located in the northwest section of the cemetery. The graves are in reasonable condition – many tombstones are broken and scattered. The plot area is exposed and close to the paths, and is easily accessed.

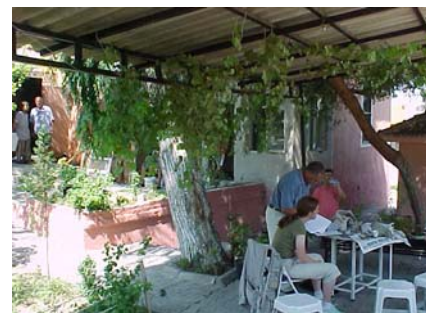
The entrance to the cemetery: the cemetery guardhouse, a Mikveh and bathrooms, a shed and a vegetable garden. A few graves are situated along the fence.
