<p>Index Card #1</p>	<p>ETZ HAYIM</p>

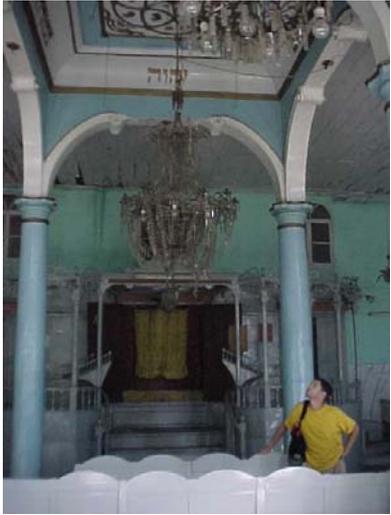
<p>General View from Inside</p>
<p>Physical Conditions</p>	<p>The building is in bad condition. The roof is badly damaged, and the structure is in danger of collapse. The “Ezrat Nashim” is not in good condition; and the use of wooden panels divides it from the larger space.</p>

From the southern Wall	No											
<p>Conclusions</p>	<ul style="list-style-type: none"> • This synagogue is the second problematic synagogue in Izmir, after the Hevra • If the roof of the synagogue is not repaired as soon as possible, this synagogue will be in the same condition as the Hevra synagogue. <p>As a recommendation, the roof of this synagogue should be repaired immediately, before it collapses.</p>
